### DODGE CALIBER CVT MULTIPLE SOLENOID FAULTS

SECONDARY SPEED SENSOR CODE

CVT2/JF011E/F1C1A/RE0F10A

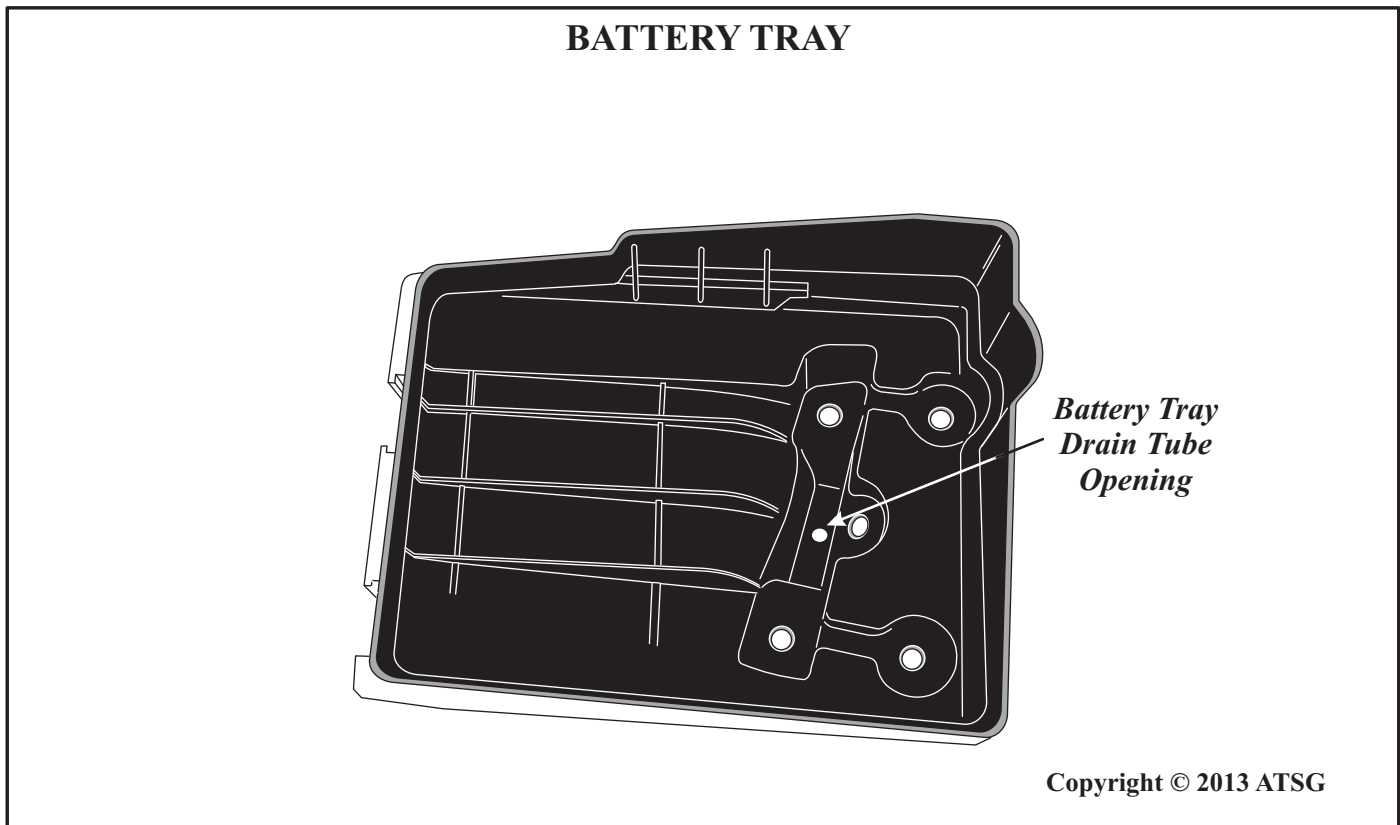
Figure 1  
Automatic Transmission Service Group

**CAUSE:** The cause may be that the wiring harness leading to the case connector on the transmission is corroded and or partially disintegrated by battery acid dripping down on to the harness. Figure 1 shows the battery tray. The drain tube exits the bottom of the tray, right above the transmission wiring harness. See Figure 2 for the location of the harness and the connector at the transmission.

**CORRECTION:** To correct this problem, re-route the drain tube so it is away from the wiring harness, or purchase the new drain tube listed in service information. Repair the wiring harness as necessary. Refer to Figures 3 and 4 for terminal location and identification at the Transmission Control Module and Figure 5 for a view of the harness connector. Note: This information also includes ohm values and solenoid location as shown in Figure 6 in case the harness is good and a solenoid circuit fault is present.

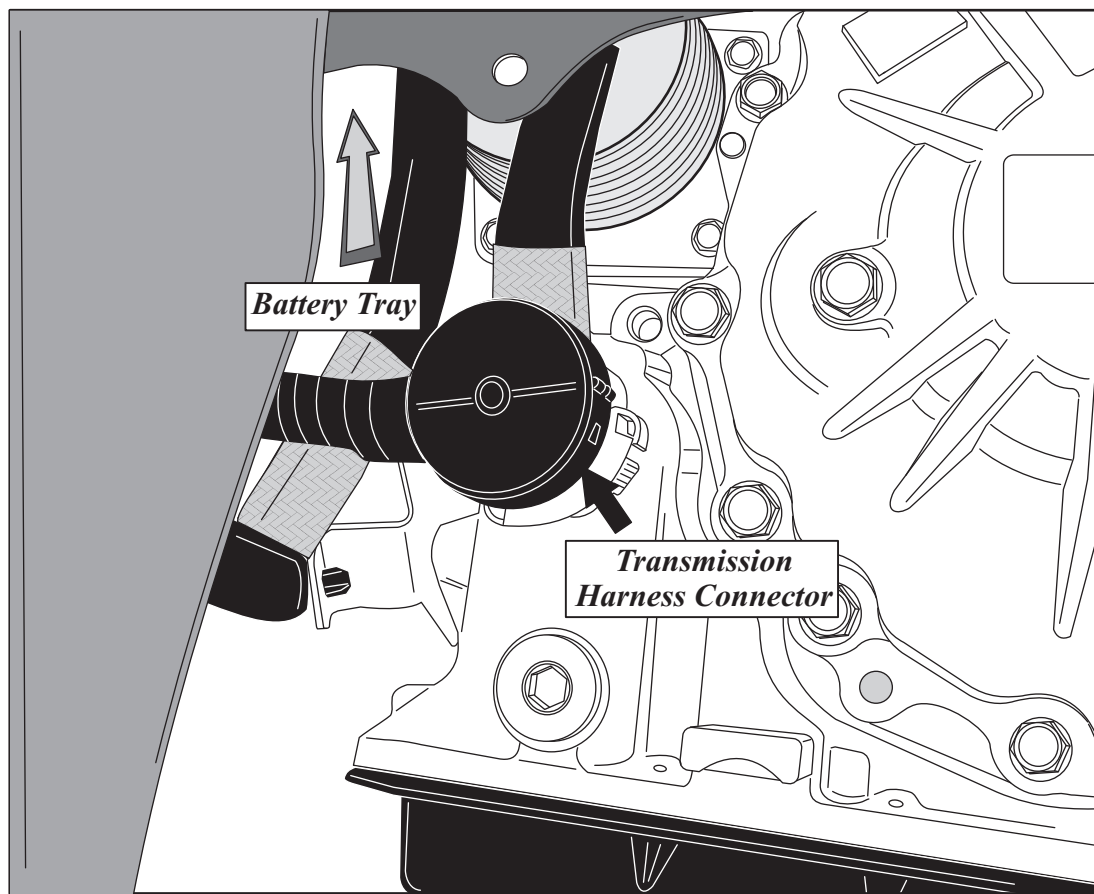
Figure 2

*The Battery tray and drain tube are located above the harness leading to the Transmission Harness connector. Battery acid will typically leak down on to the harness and corrode/disintegrate the harness protective coating and the internal wiring.*

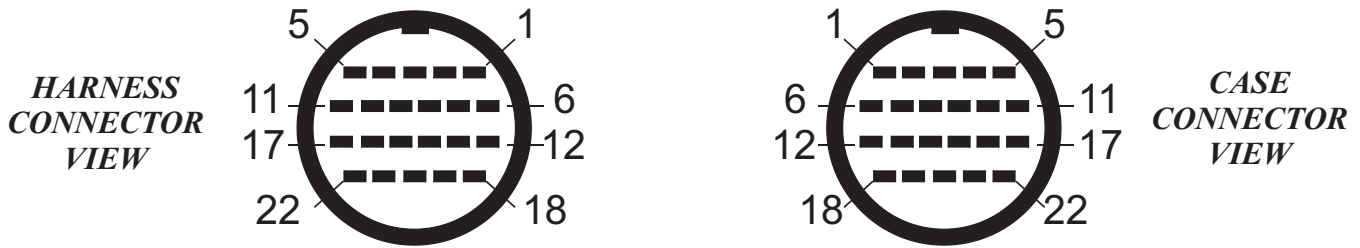
Figure 5

- PCS - 1 & 6 = 6.5 ohms
- SPSC - 2 & 6 = 6.5 ohms
- LCS - 3 & 6 = 6.5 ohms
- LSS - 4 & Case Ground = 28 ohms

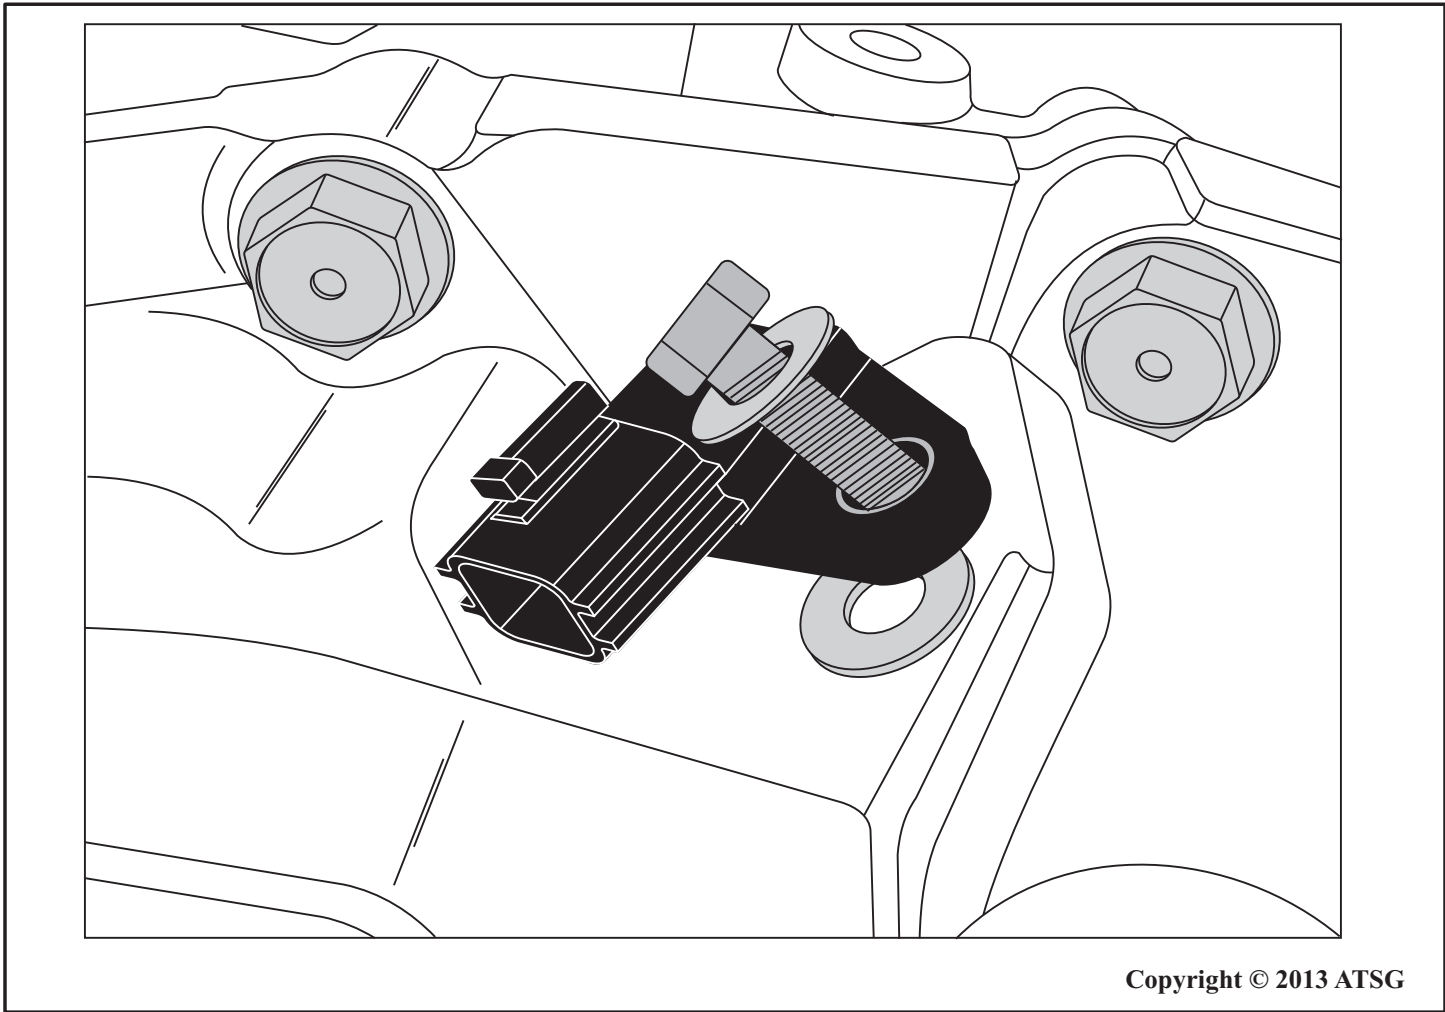
Figure 1

CAUSE: Various applications require one or more shims under the output speed sensor to maintain proper air gap between the sensor tip and signal gear (Figure 1). If the shim or shims are left off, or are placed between the attaching bolt and sensor, the tip of the sensor rests upon the signal gear. Once the gear is in rotation it damages the tip of the sensor and the signal is lost.

CORRECTION: If the shim or shims were incorrectly installed between the bolt and sensor, replace the sensor and install the shim or shims between the case and sensor.

If the shim or shims were not installed, replace the sensor and install the appropriate number of .040" shims under the output speed sensor.

The length of the speed sensor is approximately 1.140". If the depth of the speed sensor hole measures approximately the same as the sensor length, install one .040" shim under the sensor. If it measures approximately 1.100", place two .040" shims under the sensor. If it measures approximately 1.180", no shims are required.
