### DODGE CALIBER CVT MULTIPLE SOLENOID FAULTS

SECONDARY SPEED SENSOR CODE

CVT2/JF011E/F1C1A/RE0F10A

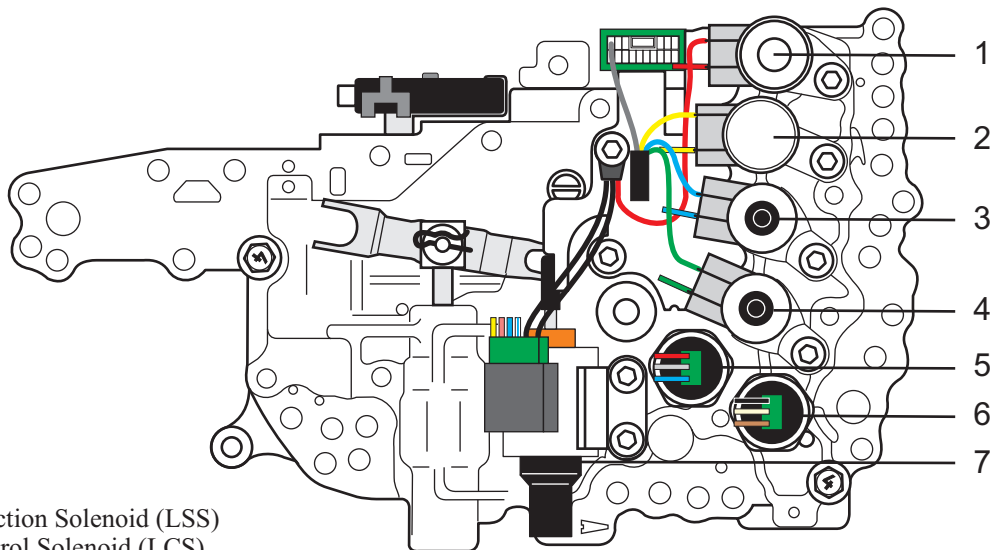
**SOLENOID LOCATIONS**

- 1. Lockup Selection Solenoid (LSS)
- 2. Lockup Control Solenoid (LCS)
- 3. Secondary Pressure Control Solenoid (SPCS)
- 4. Pressure Control Solenoid (PCS)
- 5. Primary Pressure Sensor
- 6. Secondary Pressure Sensor
- 7. Ratio Control Motor

**CORRECTION:** To correct this problem, re-route the drain tube so it is away from the wiring harness, or purchase the new drain tube listed in service information. Repair the wiring harness as necessary. Refer to Figures 3 and 4 for terminal location and identification at the Transmission Control Module and Figure 5 for a view of the harness connector. Note: This information also includes ohm values and solenoid location as shown in Figure 6 in case the harness is good and a solenoid circuit fault is present.
